Project No: A-2320

METALLURGICAL ANALYSIS OF FRACTURED GEARS

Conducted for Donald MacMillan & Son Inc., Macon, GA

Dr. B. R. Livesay
Georgia Institute of Technology
Atlanta, Georgia 30332

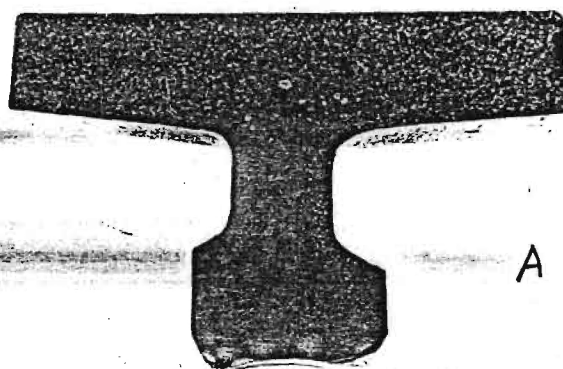
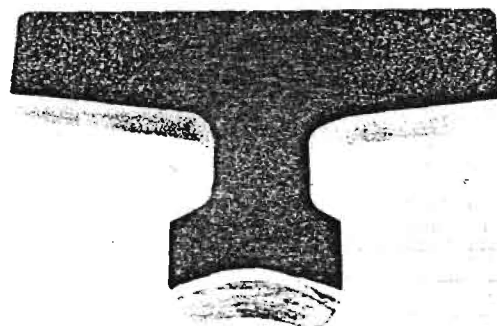
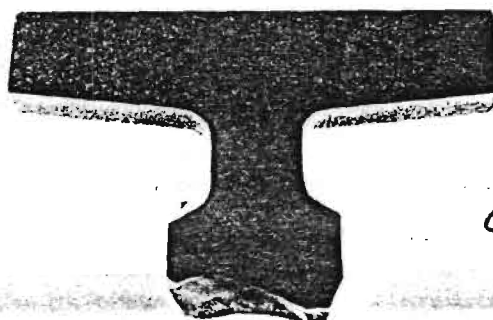
The three copper alloy failed gears which you sent to us were sectioned and subjected to microstructural analysis. The sections were cut radially and parallel to the axis of the gears so that the sections appear as shown in Figure 1. Subsequent to standard metallurgical grinding and polishing procedures, the specimens were examined. Pitting was clearly evident throughout the material near the gear shaft. The pitting is visible even on the approximately one to one photographs contained in Figure 1. The letters in the notation, i.e., Figure 1A, denotes the gear arbitrarily labeled A. As seen in Figure 1A, the gross pitting extended throughout the shaft section of Gear A whereas the pits were smaller towards the central parts of the material in Gears B and C.

FIGURE 1 Photographs of Ground and Polished Sections Cut from Gears. The Upper Part of the Photos are From the Shaft Region and The Lower Part the Teeth. Magnification - About 1X

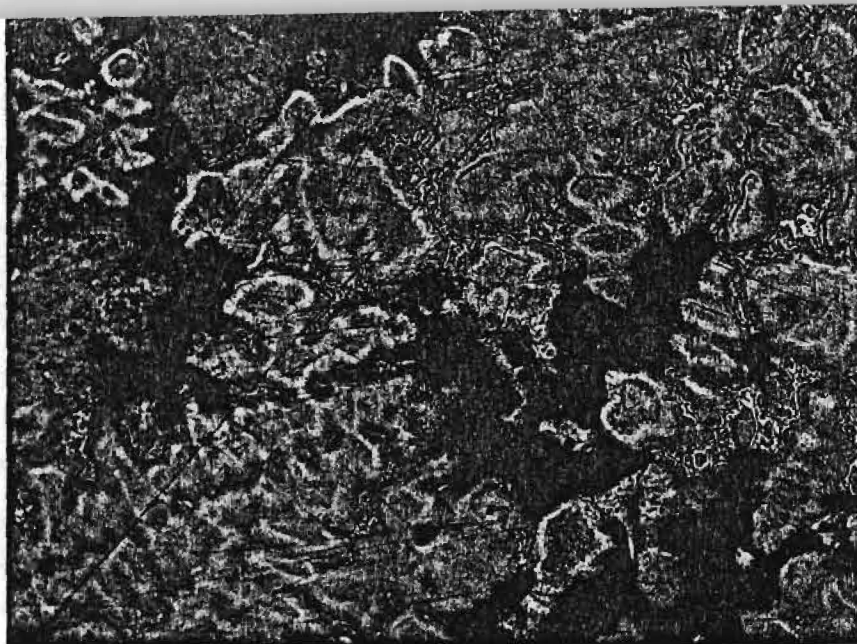
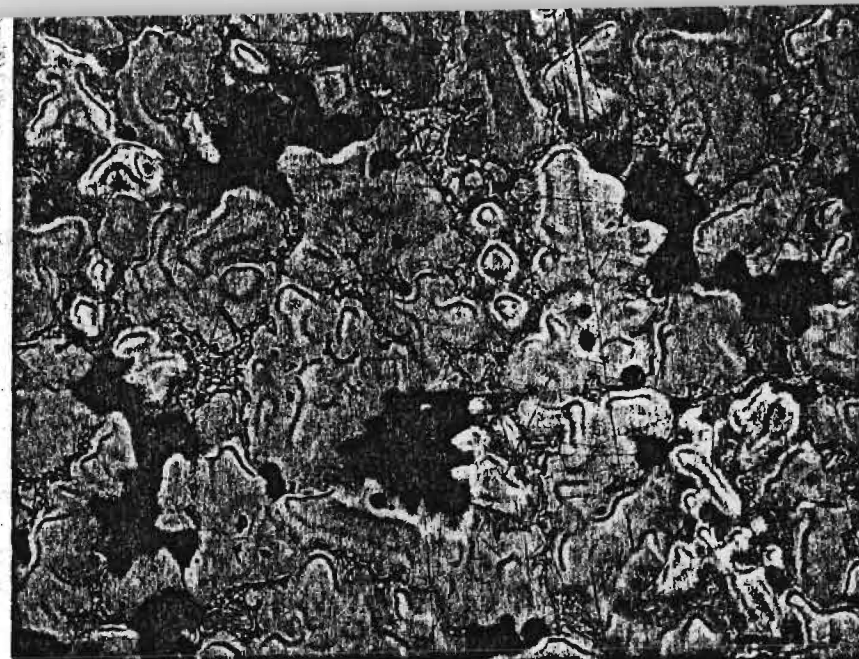
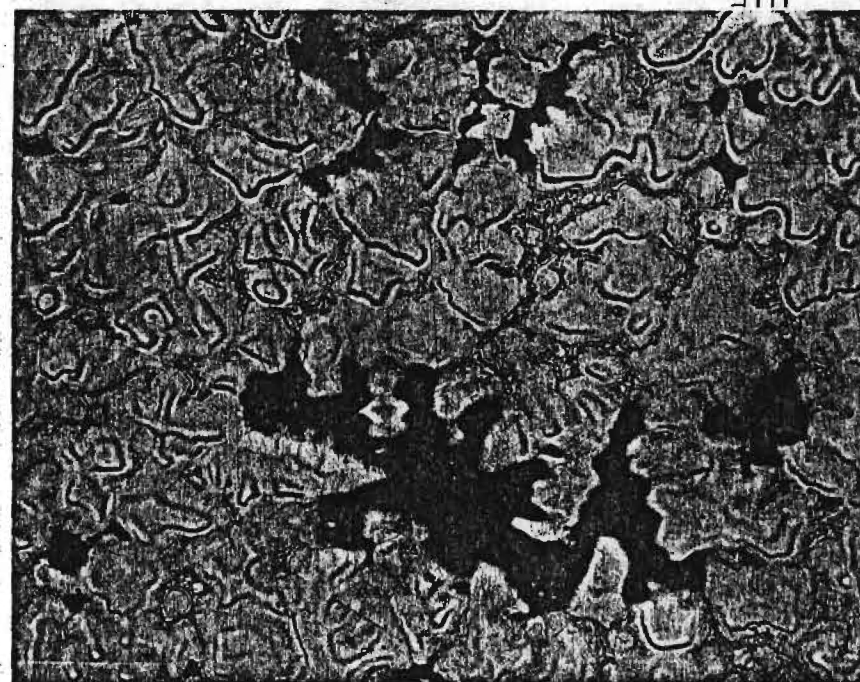
Figure 2 Micrographs of
Gear Material Near Shaft
Magnification 100 X

The sections were then etched and examined under higher magnification. Figures 2 show the microstructure at 100X for the material near the shaft for each of the three gears as indicated. Figure 3 was made of the material in the neighborhood of the gear teeth. You will note that small pits are still present in this region but of much smaller size and density than those present in the material near the shaft. In addition, details of the microstructure apart from the pits are quite different in the two regions. The dendrites are much larger in the

The material in the regions near the shaft has a high pitting density. Cavities of this sort sharply reduce the fatigue strength of any structural member. Pits are also found distributed throughout the remainder of the material but both the density and cavity size is somewhat lower. It was also clear that the microstructure of the near-shaft material is different from that of the near-tooth alloy. The large dendrites and correspondingly larger Sn rich phase might reduce fatigue strength also. However, the pits are so dominant that it is felt here that the fatigue fractures are due to fatigue crack initiation at the pit cavities.

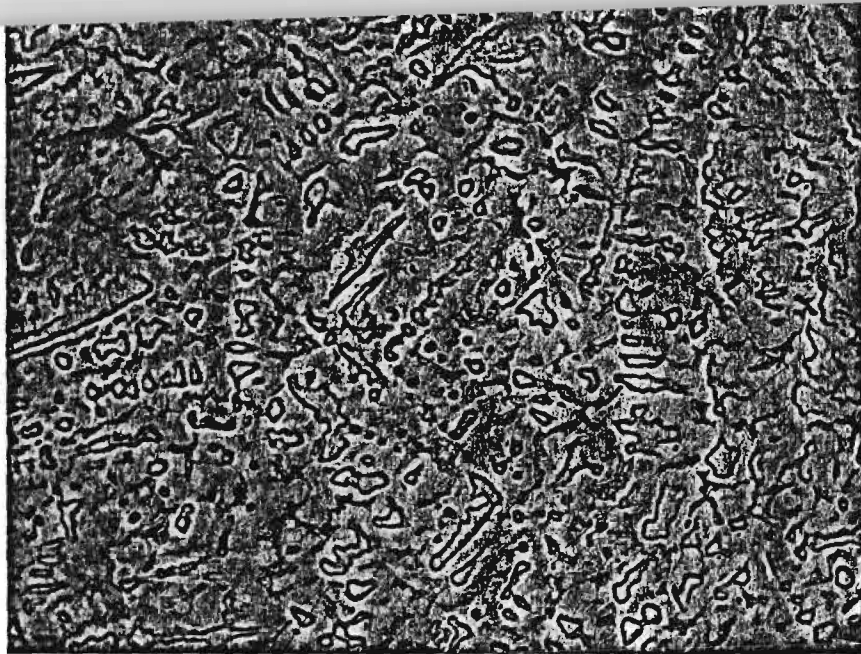
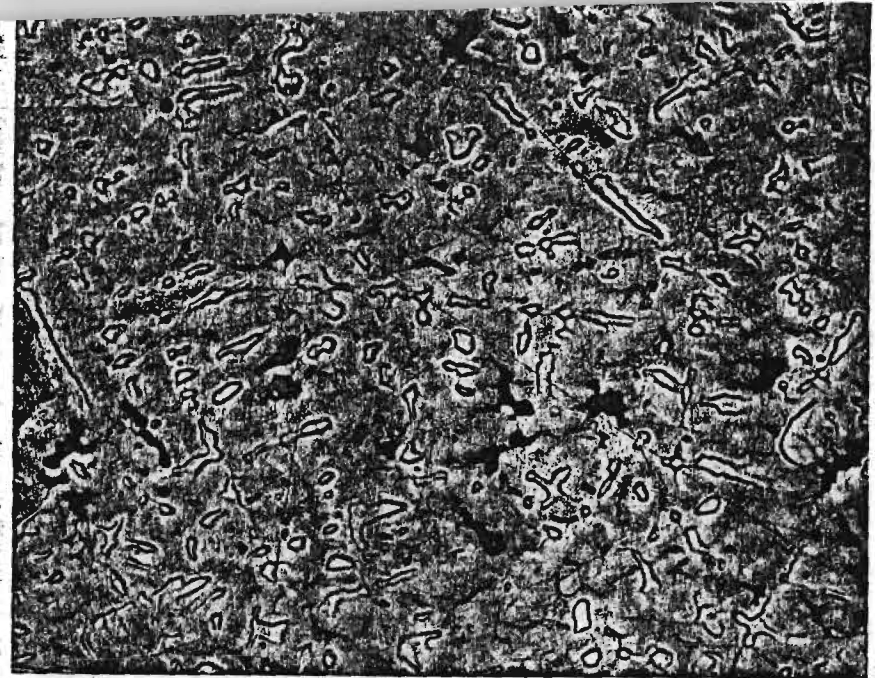
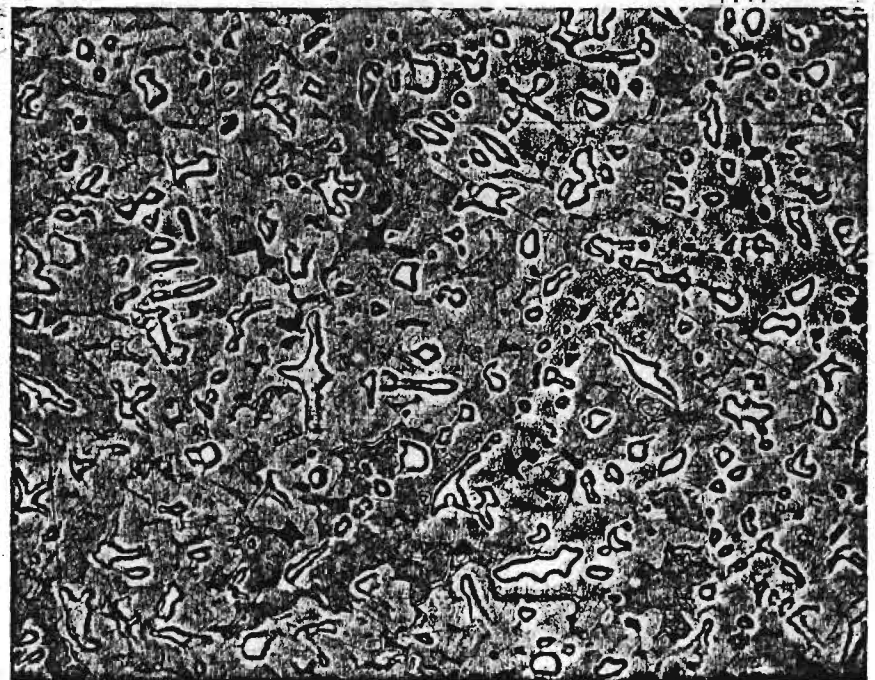
Figure 3 Micrographs of Gear
Material Near Tooth of Gear

shaft region than in the tooth. Also, the phase seen as darker grey occupies a much greater volume of the material in the shaft region than in the tooth region. The composition of this phase was thus of interest so a compositional analysis was conducted on a piece of specimen B. These data are attached as Figures 4, 5, and 6.

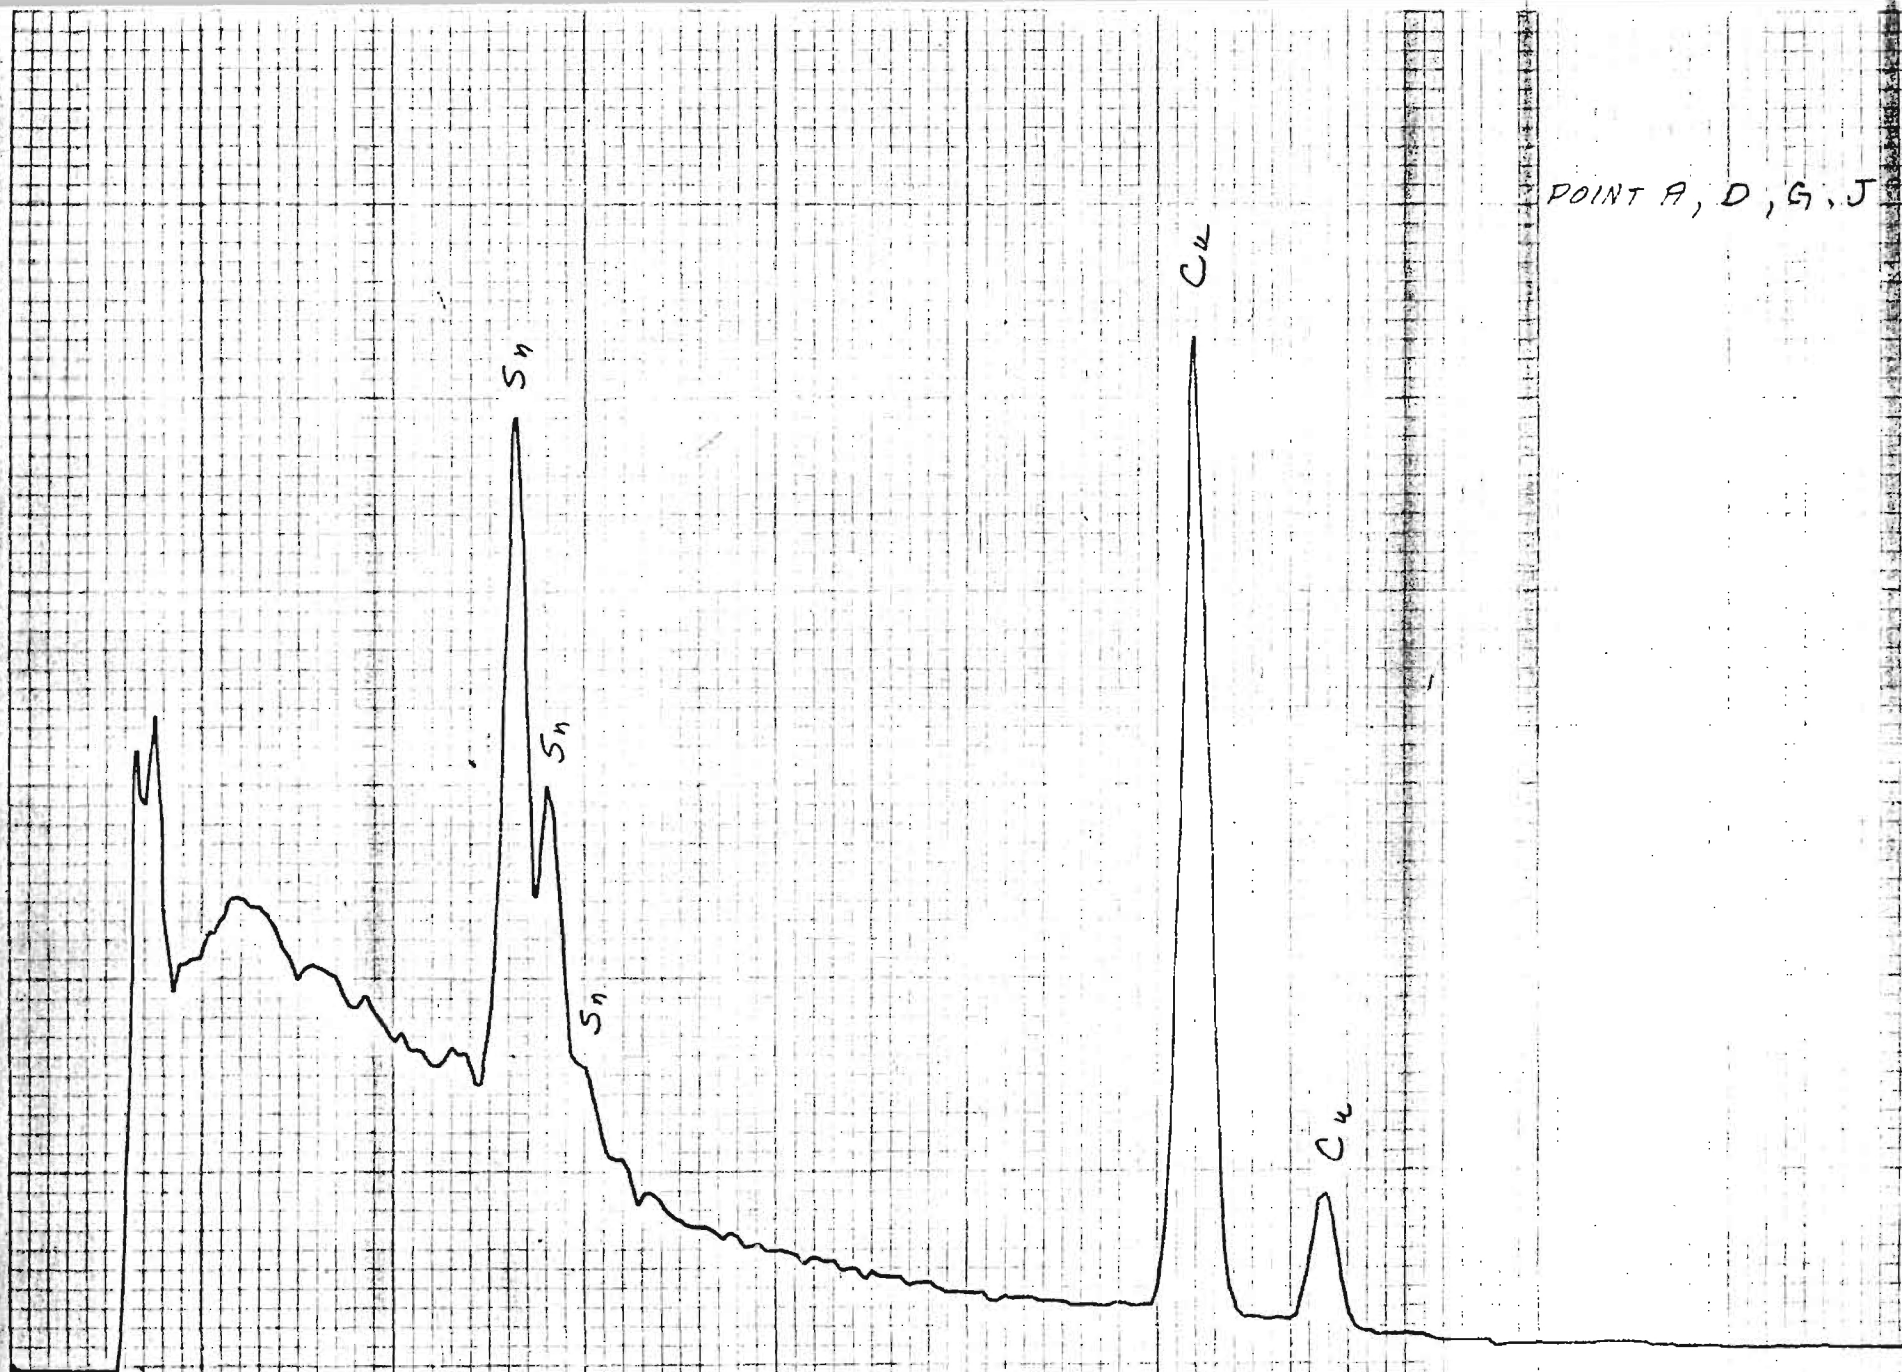
The compositional analysis was carried out in the scanning electron microscope (SEM). SEM micrographs of this specimen are shown in Figures 7, 8, and 9. The magnification in Figure 7 is 200X but for Figures 8 and 9 2,000X. The composition of the regions is indicated for the points defined by the letters marked on Figures 8 and 9. The phase in question is obviously rich in tin (Sn) and thus likely to be somewhat brittle.

Figure 4 Composition of Material in Regions A, D, G and J
as Derived in Figures 8 and 9. Note High Sn Content of Phase

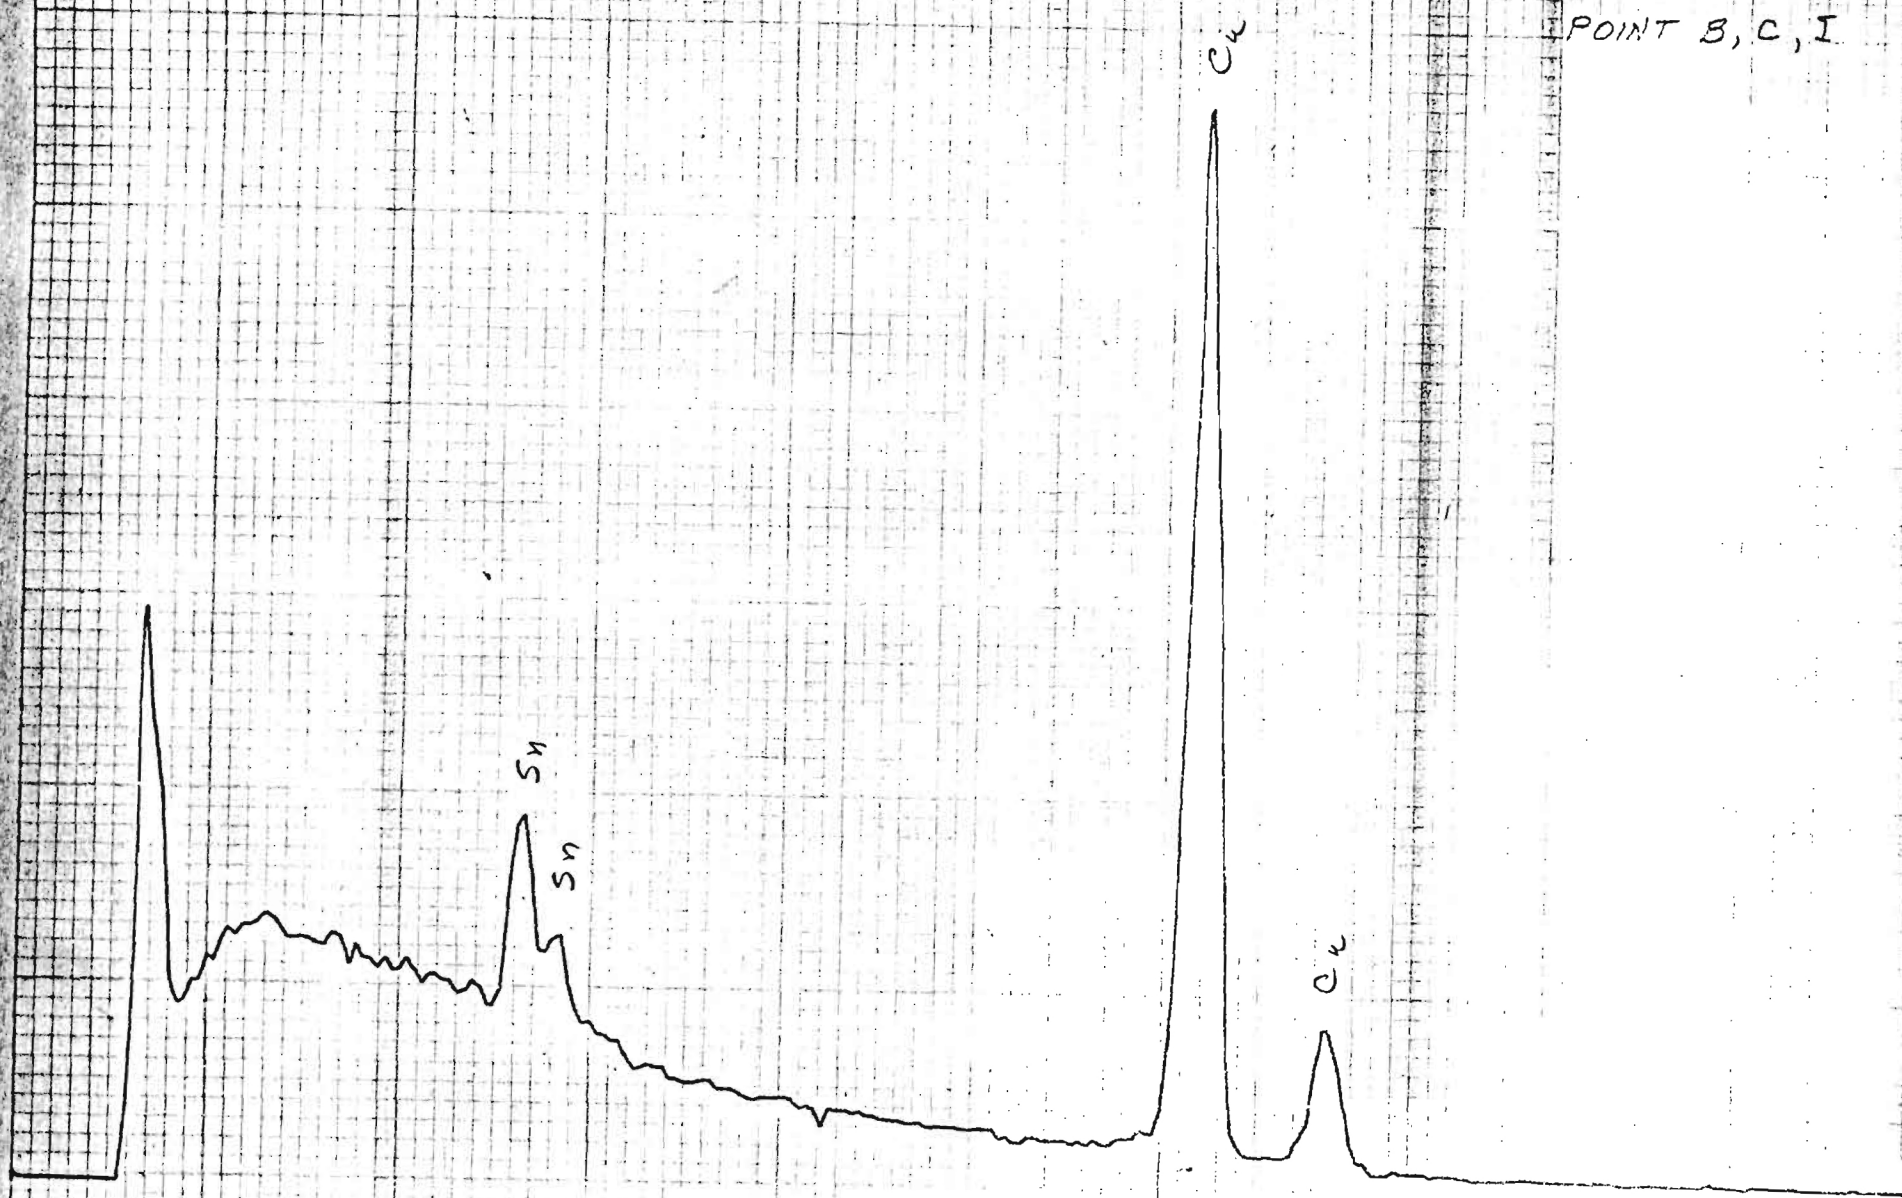
Figure 5 Composition of Material in Regions B, C and I as
Defined in Figures 8 and 9

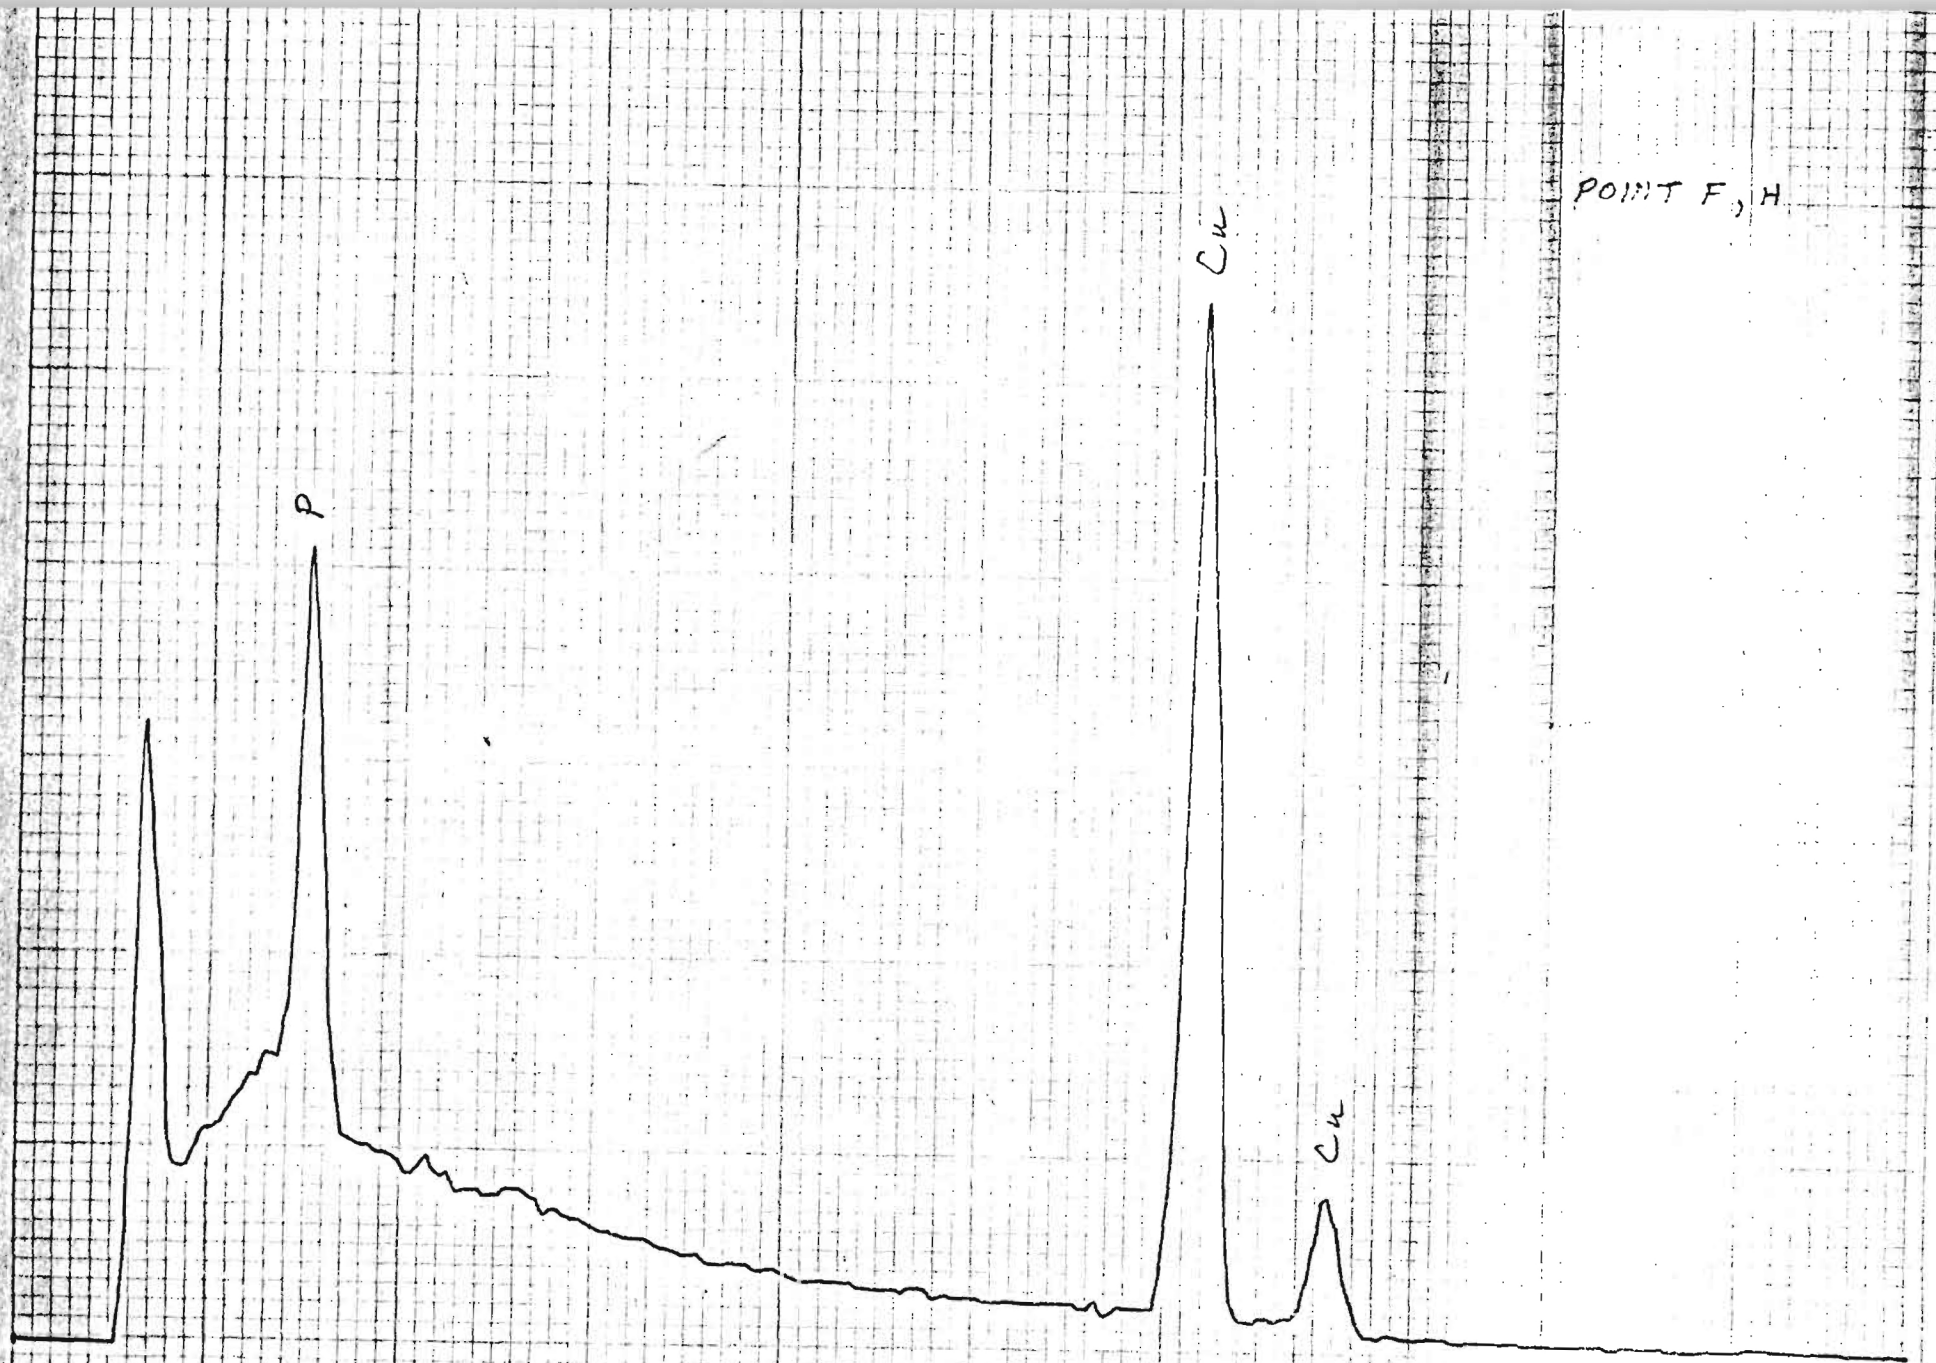
Figure 6 Composition of Material in Regions F and H as Defined in Figure 9. Note P content of this Phase

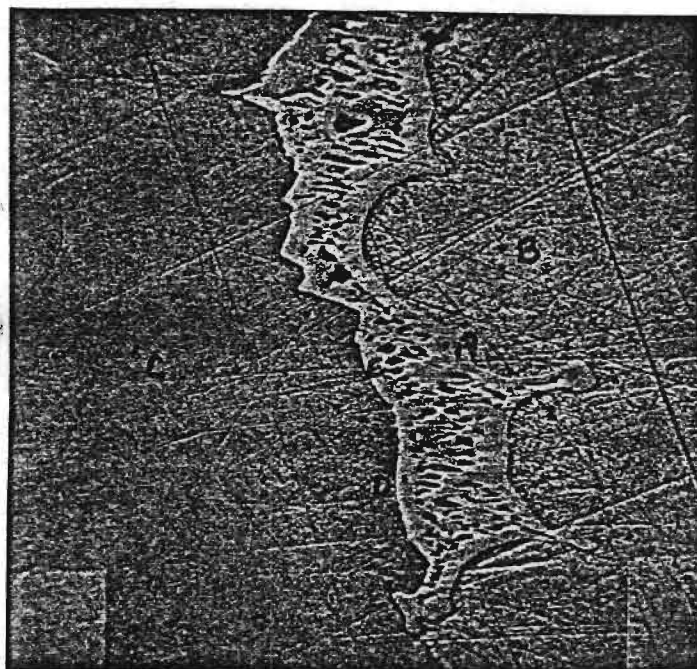
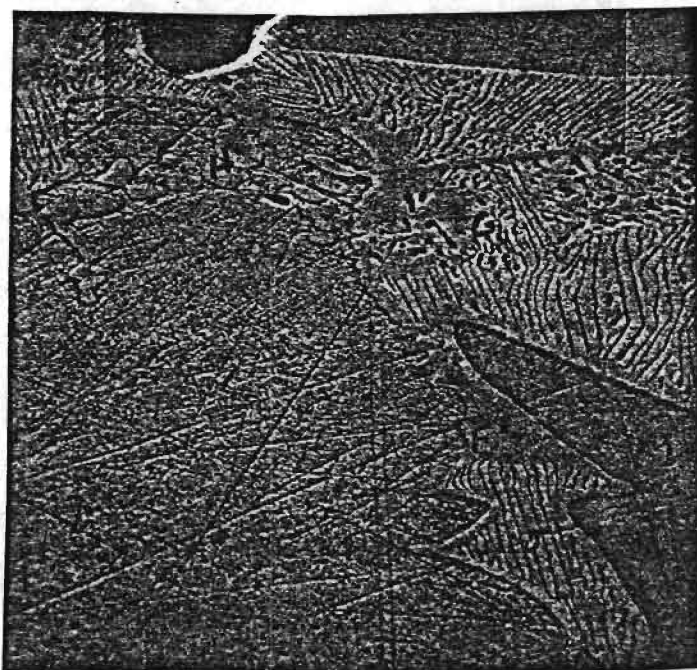
Scanning Electron Micrographs of
Material Near Shaft Taken
From Gear B
